## Assessment of Existing Weir Performance Index Integrated with Variability of Crop Productivity

This research intends to assess the existing performance index of the weir that is integrated with the variability of crop productivity as a strategic effort in supporting the building of a weir performance index model scientifically which so far, the assessment now is based on the consensus result. The methodology consists of a field survey, inventory of weir physics, analysis of performance weight, and then determining the performance of each component of irrigation. The research result shows that of 28 weirs as the samples of research, only 1 (one) weir (3.60%) is in good condition, 18 (eighteen) weirs (64.3%) are in moderate condition, and 9 (nine) weirs (32.10%) are in bad condition. The dominant of weir's condition is on the moderate and bad conditions, it shows that there is a need to increase the effective and planned operation and maintenance activity. The performance index model of weirs and the relation between weir performance and variability of crop productivity can be used as the technical monitoring tool for detecting the decreasing of weir function and to support the f

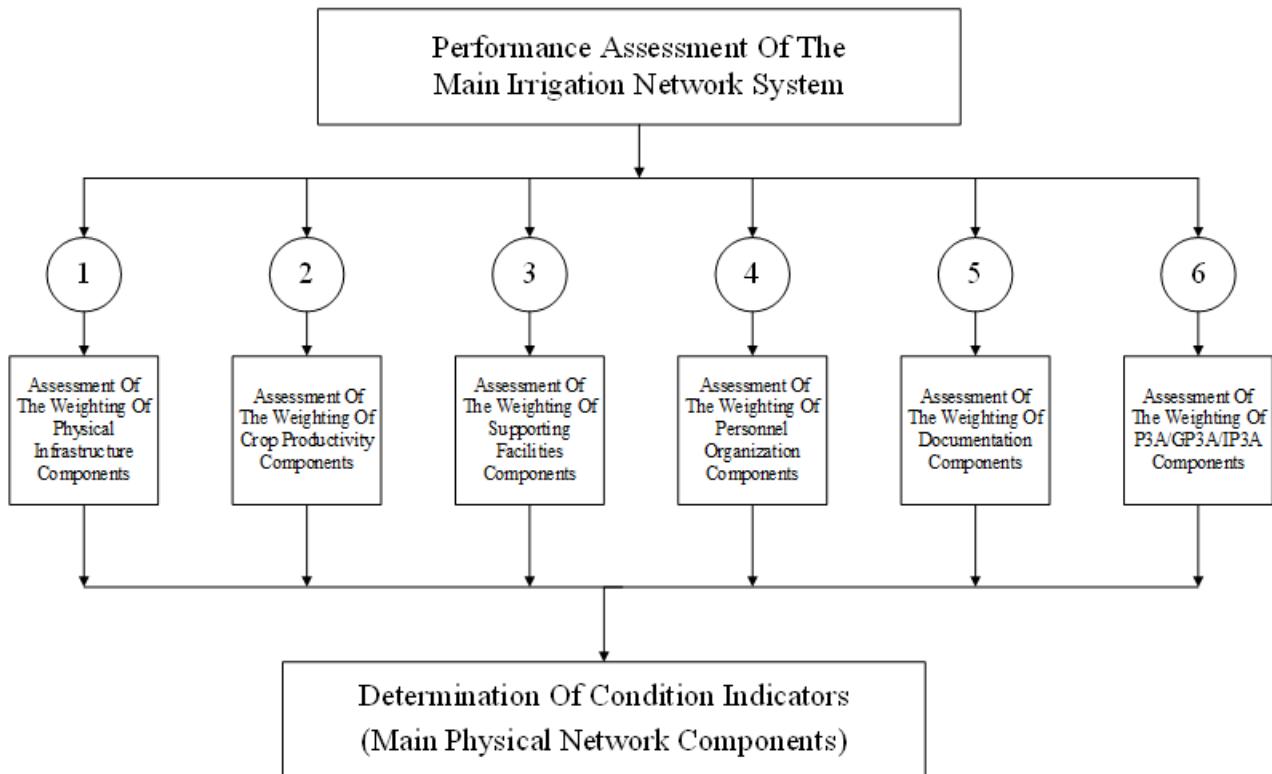
**Figure 1.** Performance Evaluation of Irrigation System Based on the Ministry Rule of General Work and Housing (Permen PUPR) No. 12/2015.

Based on the Ministry Rule of Public Work and Housing (Permen PUPR) No. 12, 2015. about the exploitation and maintenance of irrigation networks the irrigation system performance is determined in index form that is assessed based on the 6 parameters that are physical infrastructure, crop productivity, supporting structure, personnel organization, documentation, and farmers' association for water users (P3A/GP3A/IP3A) which are presented in Figure 1.

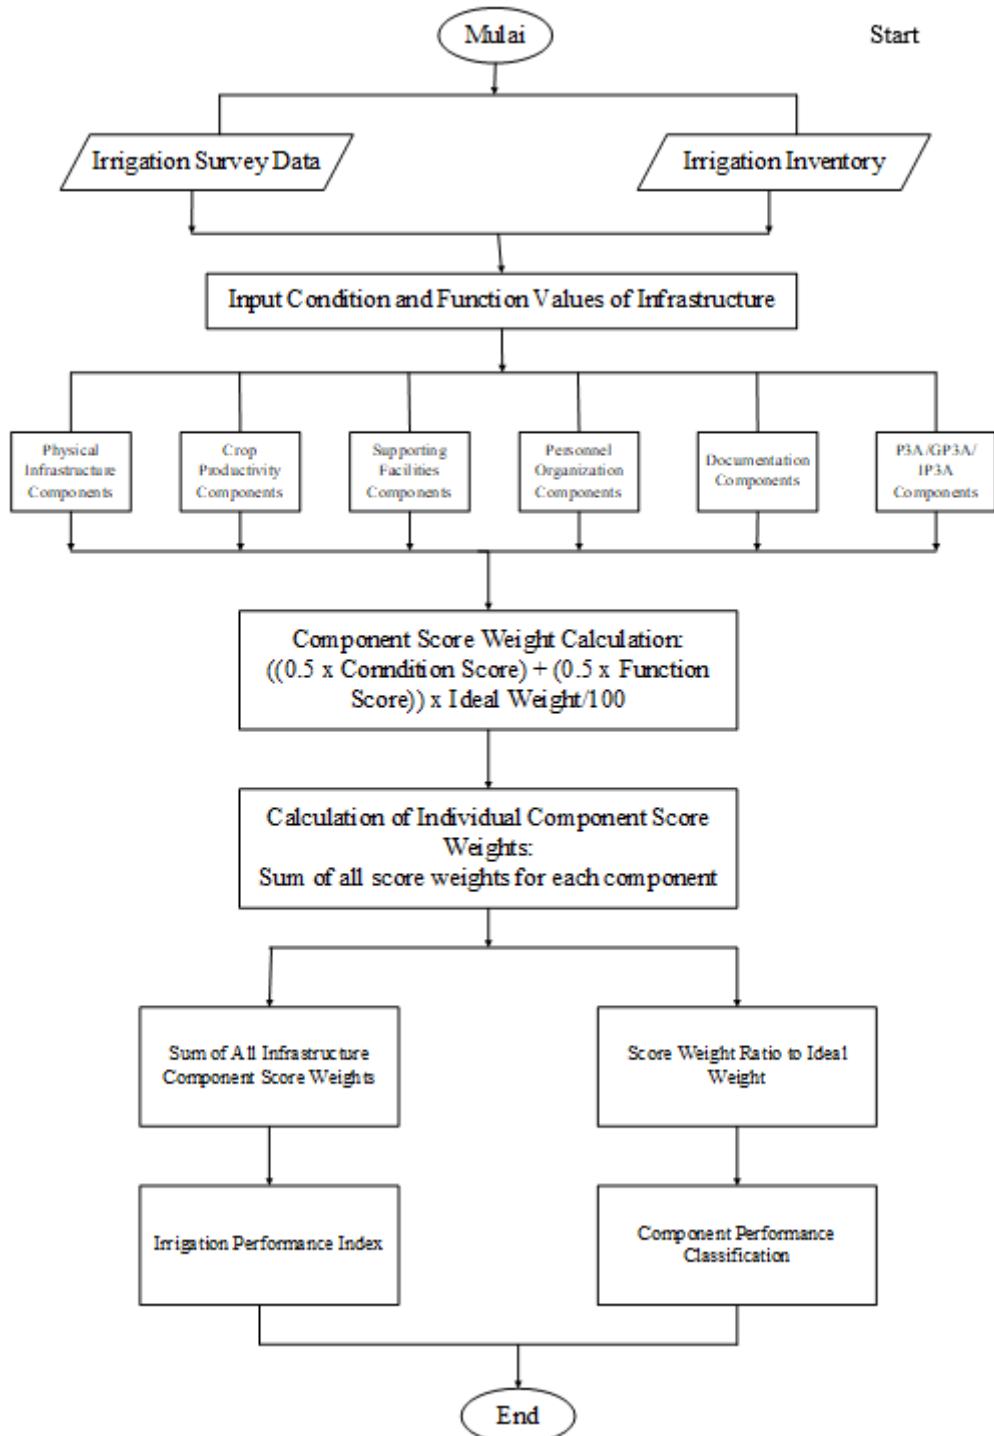
**Figure 2.** Evaluation Method of Irrigation Performance.**Table 2.** Weight of Irrigation Performance.

In accordance with this research aim, which is to obtain the solution so the weir performance can maximally work, that is reviewed from physical as well as non-physical aspects by carrying out the modification of Permen PUPR No. 12, 2015, so the assessment is carried out on the irrigation components that are the main building or weir until the primary channel. However, the assessment method is presented in Figure 2.

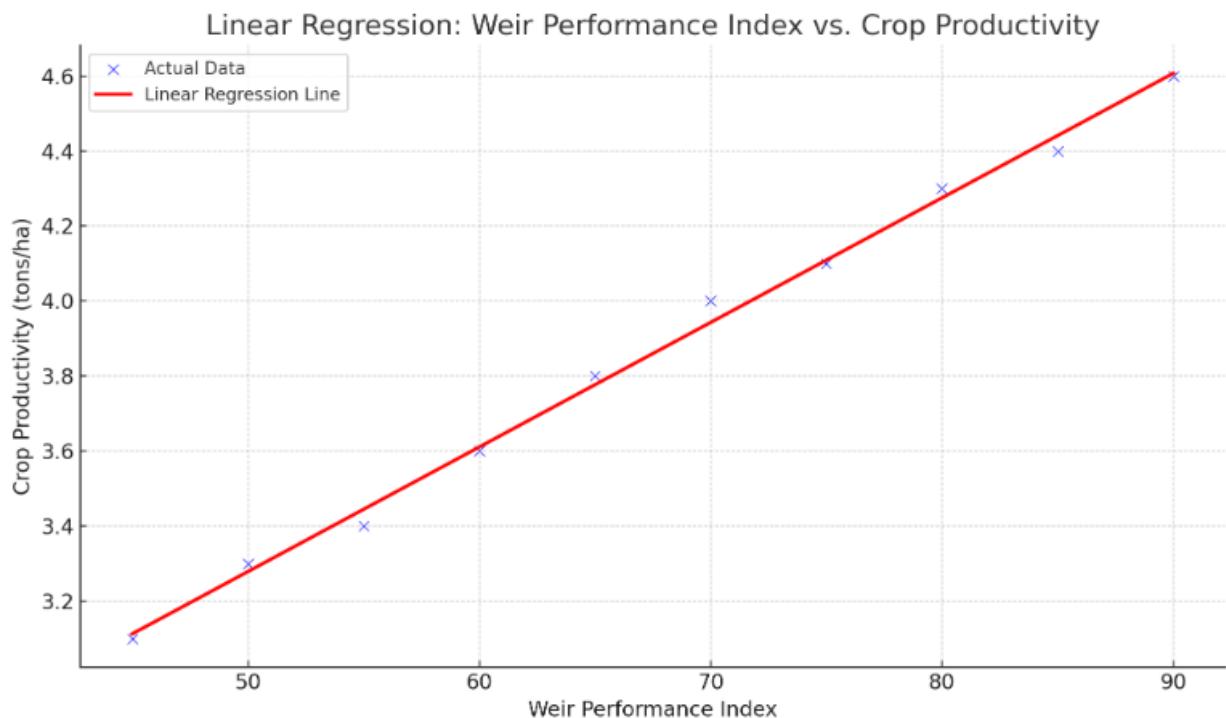
**Figure 3.** Illustration of Relation Curve between Crop Productivity and Performance Index of Weir.

The statistical method of linear regression is used for analyzing the relation between a dependent variable (in this case is crop productivity) and one or more independent variables or the value of the weir performance index. The main aim of linear regression is to predict the dependent variable based on the independent variable, with the stages as follows: 1) To analyze the productivity of paddy due to the formulation that has been available in Permen PU; 2) To determine the category of assessment of the productivity of paddy; 3) To relate the performance index result and survey result of crop productivity (ton/ha) into graphic form with the x-axis as the independent variable (weir performance index) and the y-ordinate as the dependent variable (crop productivity); and 4) to analyze the coefficient of determination ( $R^2$ ) as presented in Figure 3. Table 3 presents the percentage evaluation category of paddy productivity.
